# Manhole Inspection Summary

Manhole # S19GG2017MH

**Location** Address: **1330 SMITH AVE**

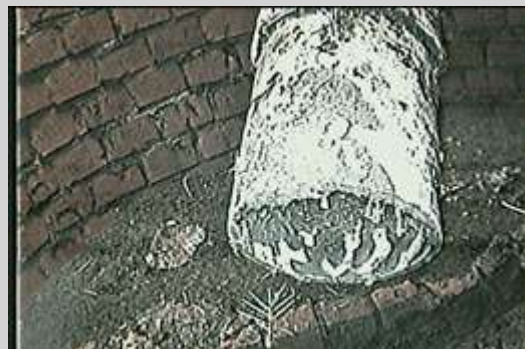
### Drop In @ 4 O'Clock

Infiltration: **Evidence** Pipe Seal Cond: **Broken**

Drop: **Inside** Rod and Bar  
Angled: **Yes** Reading: **7.87** (ft.)  
Inv Depth: **8.87** (ft.)

Drop Condition: **Open**
